Insch Asset Condition Assessment

Final Report

01 May 2018

A structural survey was undertaken along the main watercourses of Inch in Aberdeenshire; the Shevock Burn, the Valentines Burn, the Temple Stripe, the Mill of Rothney, the Newton of Rothney and Field Drains of the Shevock Burn and the Valentines Burn.

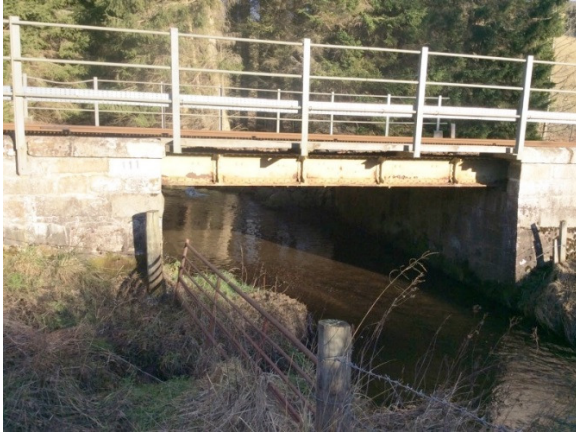
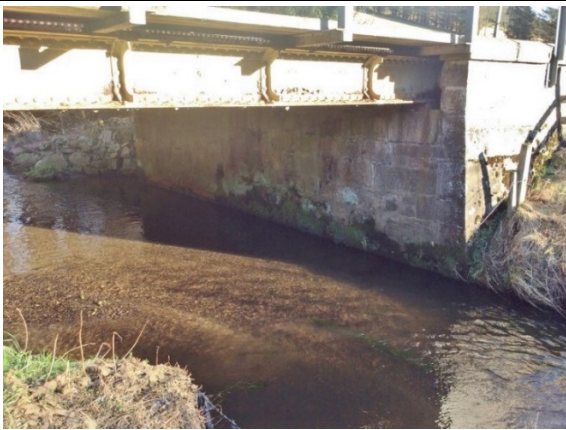
1- ANI1 293/111 Railway bridge (Refer to Figure 2-1)

Type: Single Span Railway Bridge
Upstream grid ref: NJ 60666
27895
Span (m): 3 approx.
Material: Masonry Abutments, Steel Deck
Condition: Grade 2 (Good)
Part of FPS: No
Comments:
 Localised corrosion of steel beam.
 Minor cracks of abutments.
 Water stains at both abutments.
Risk of blockage: Low
Maintenance: None required
Quick Win: N/A

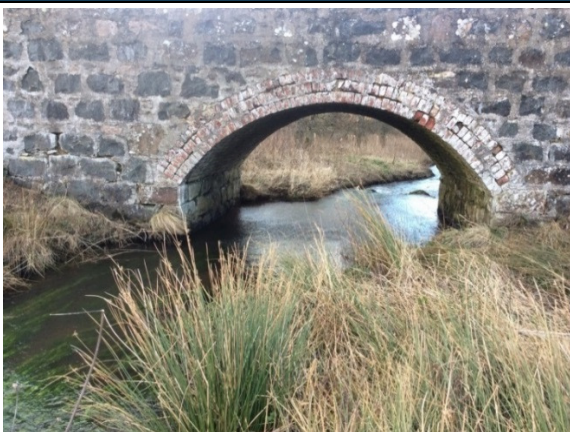
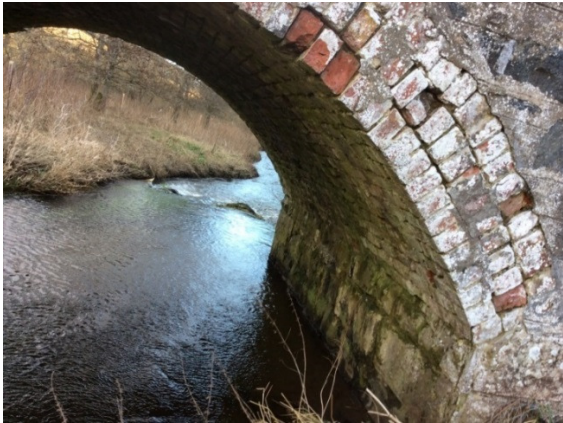
2- Masonry bridge (Refer to Figure 2-1)

Type: Arch Bridge
Upstream grid ref: NJ 60974
27754
Span (m): 2 approx.
Material: Masonry, Brick
Condition: Grade 3 (Fair)
Part of FPS: No
Comments:
 Loss of joint material.
 Masonry material missing.
 Extensive crack on left abutment.
 Arch deformed in places.
 Minor erosion of left bank downstream.
Risk of blockage: Moderate
Maintenance: Keep watercourse free of debris.
Quick Win: N/A

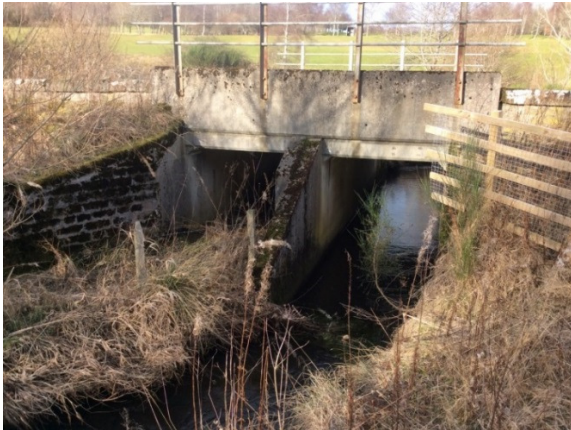
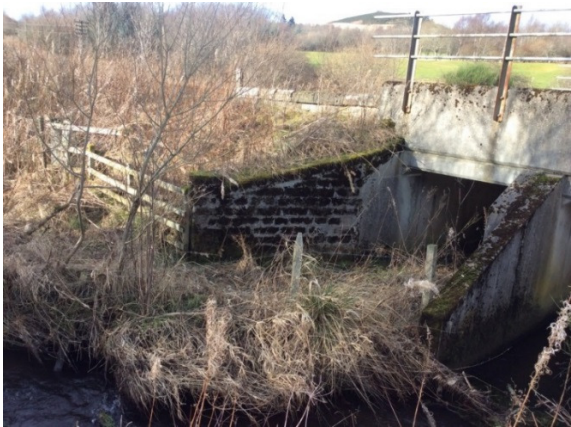
3 – ANI1 293/109 Railway Bridge (Refer to Figure 2-2)

Type: Bridge
Upstream grid ref: NJ 61995 27655
Span (m): 1 approx. each opening
Material: Concrete Abutments and Deck
Condition: Grade 2 (Good)
Part of FPS: No
Comments:
 Water stains.
 No significant defects of structure.
 Corrosion of parapet.
 High vegetation growth upstream.
Risk of blockage: Moderate
Maintenance: Keep watercourse free of debris.
Quick Win: Remove excess vegetation, cut trees upstream.

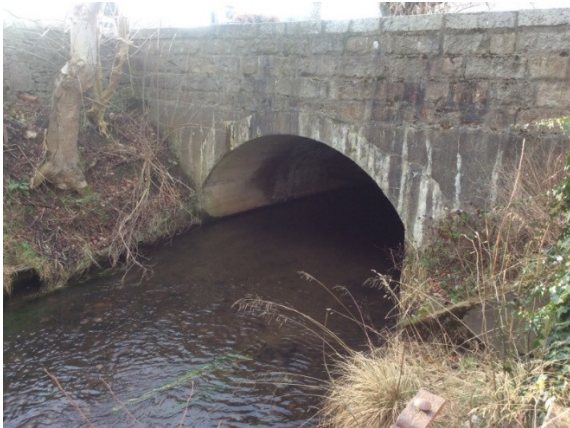
6 – Bridge of Rothney (Refer to Figure 2-3)

Type: Masonry Arch Bridge
Upstream grid ref: NJ 62971 27868
Span (m): 4.3
Material: Masonry
Condition: Grade 2 (Good)
Part of FPS: No
Comments:
 Short cracks of arch.
 Seeping joints.
 Sound abutments.
 Potential risk of scour very low (Aberdeenshire Council¹).
Risk of blockage: Moderate
Maintenance: Keep watercourse free of debris
Quick Win: N/A

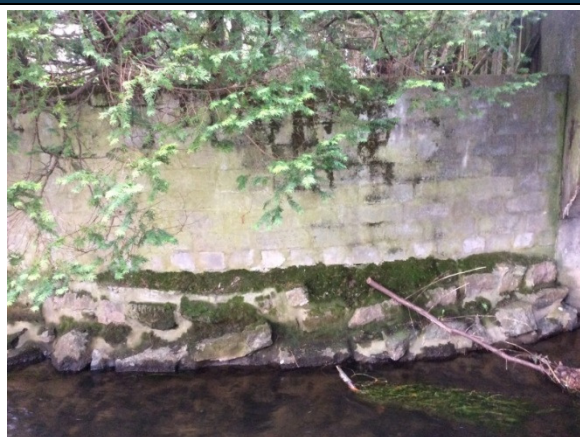
8 – Wall (Refer to Figure 2-3)

Type: Flood Wall
Upstream grid ref: NJ 63423
27985
Material: Masonry
Condition: Grade 3 (Fair)
Part of FPS: No
Comments:
 Vegetation growth between
 blockwork.
 Attached to the upstream side of
 the Bridge of Inch.
Risk of blockage: Low
Maintenance: None required
Quick Win: N/A

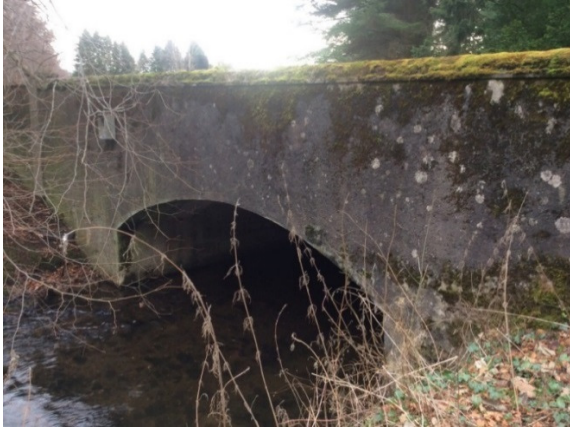
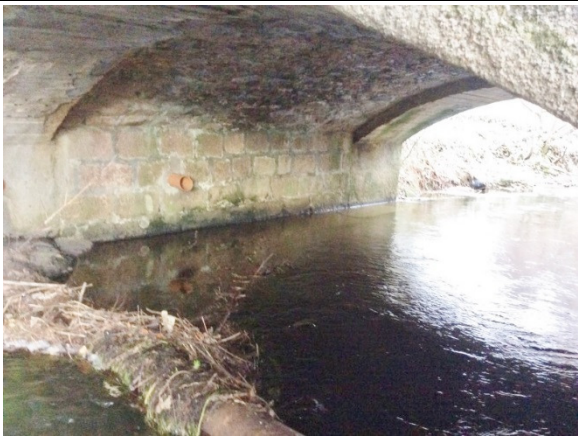
9 – Bridge of Insch (Refer to Figure 2-3)

Type: Masonry Arch Bridge
Upstream grid ref: NJ 63428 27991
Span (m): 5.13
Material: Masonry
Condition: Grade 2 (Good)
Part of FPS: No
Comments:
 No deformation of arch.
 Minor spalling.
 Moss growth on top.
 Gabion baskets directly downstream.
 Service pipe downstream.
Risk of blockage: Moderate
Maintenance: Keep watercourse free of debris.
Quick Win: N/A

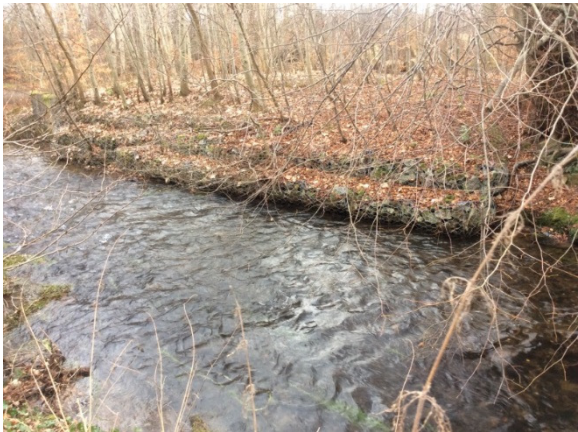
10 – Gabion baskets (Refer to Figure 2-3)

Type: Gabions
Upstream grid ref: NJ 63432 27986
Length (m): 25 approx.
Material: Masonry
Condition: Grade 2 (Good)
Part of FPS: No
Comments:
 Distortion of alignment.
 Evidence of sliding.
 Well-packed.
Risk of blockage: Low
Maintenance: Keep watercourse and trash screen free of debris.
Quick Win: N/A

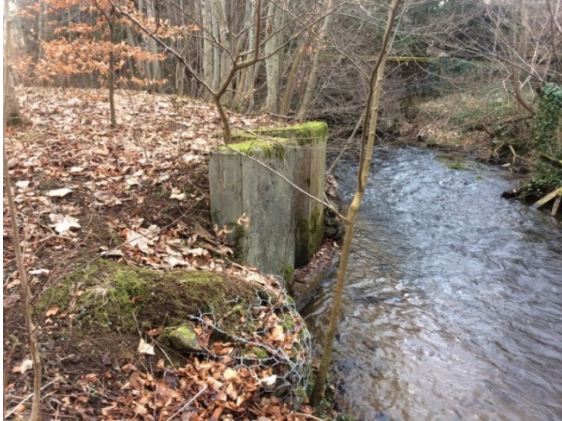
11 – Retaining Wall and Outfall (Refer to Figure 2-3)

Type: Concrete Wall, Outfall with Trash Screen
Upstream grid ref: NJ 63453 27998
Height (m): 1.6
Thickness (m): 0.2
Length (m): 3 approx.
Material: Concrete
Condition: Grade 2 (Good)
Part of FPS: No
Comments:
 No significant defects.
 Moss growth on wall.
Risk of blockage: High
Maintenance: Keep watercourse and trash screen free of debris
Quick Win: N/A

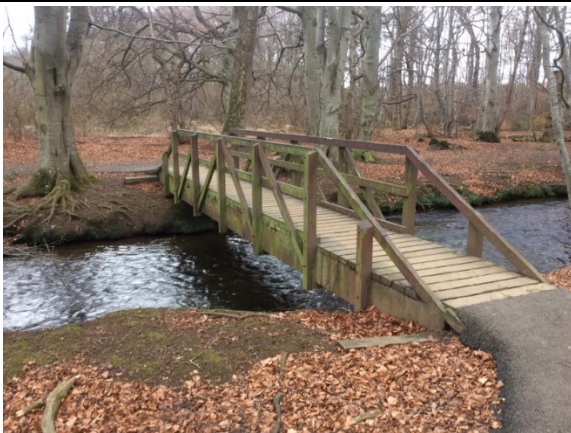
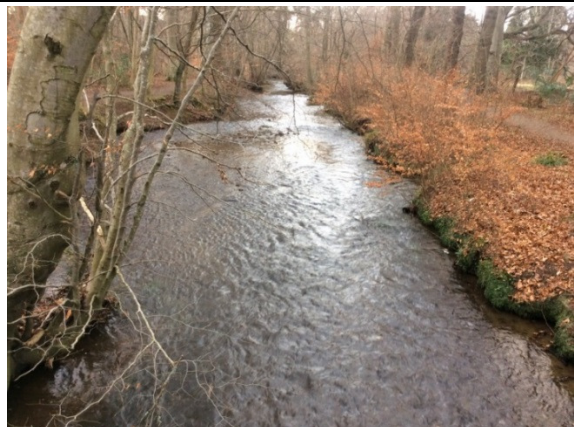
12 – Insch Meadows Pedestrian Bridge (Refer to Figure 2-3)

Type: Timber Footbridge
Upstream grid ref: NJ 63496 28030
Span (m): 6 approx.
Width (m): 1.05
Material: Timber
Condition: Grade 2 (Good)
Part of FPS: No
Comments:
 Handrails show signs of rot.
 Minor erosion of banks upstream and downstream.
 No deformation of timber beam.
Risk of blockage: Moderate
Maintenance: Keep watercourse free of debris.
Quick Win: N/A

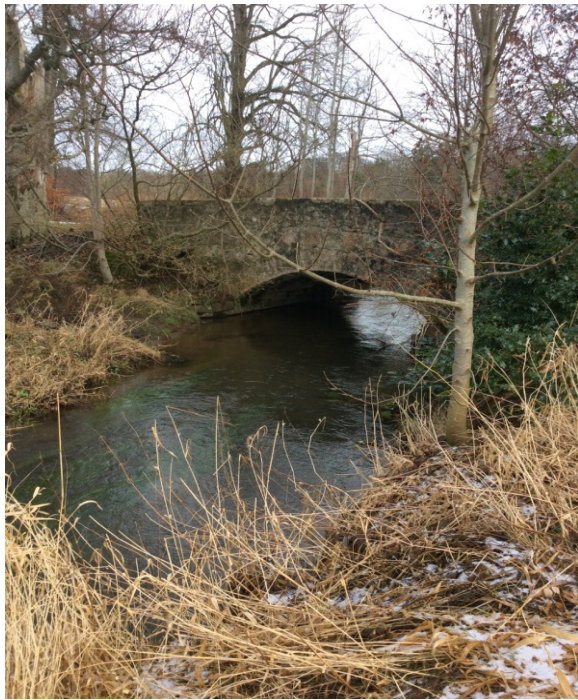
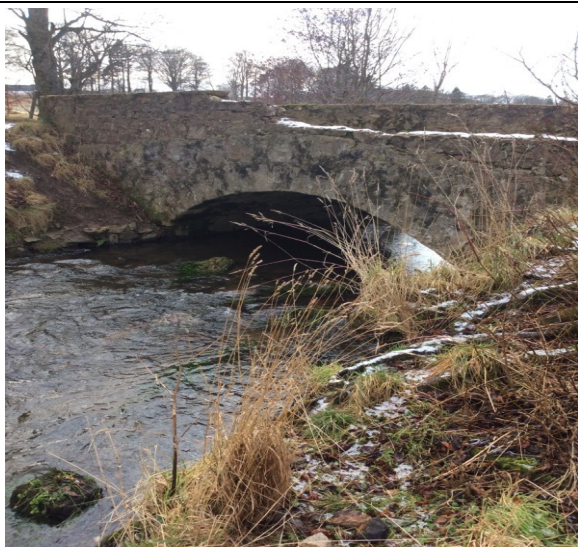
13 – Drumrossie House Bridge (Refer to Figure 2-4)

Type: Masonry Arch Bridge
Upstream grid ref: NJ 63972 27946
Span (m): 10.5
Material: Masonry
Condition: Grade 4 (Poor)
Part of FPS: No
Comments:
 Masonry missing (especially on parapet).
 Loss of mortar.
Risk of blockage: Moderate
Maintenance: Keep watercourse free of debris
Quick Win: N/A

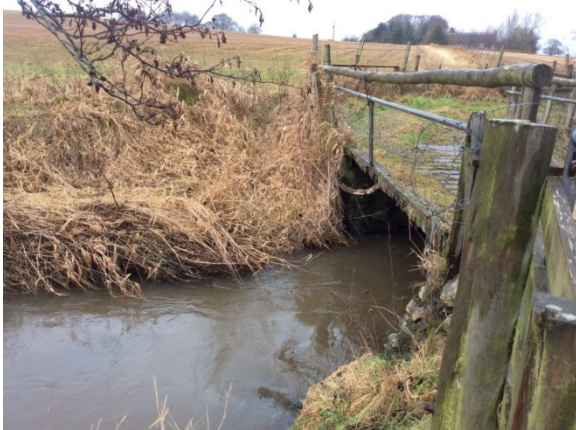
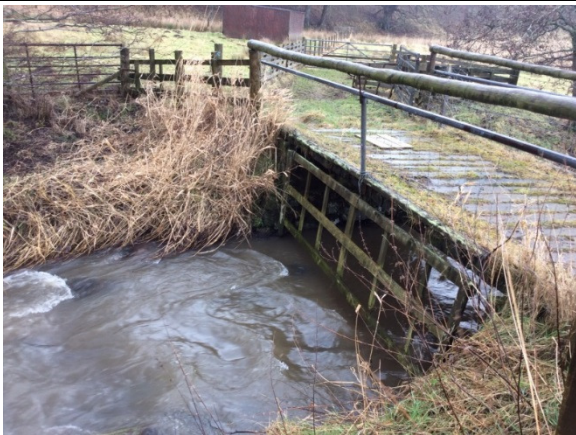
14 – Mains of Rothney Footbridge (Refer to Figure 2-4)

Type: Pedestrian Bridge
Upstream grid ref: NJ 64284 28405
Span (m): Unknown
Material: Timber/ Steel handrails and wire
Condition: Grade 4 (Poor)
Part of FPS: No
Comments:
 Rotten timber.
 Vegetation growth between timber planks.
 Distorted handrails.
Risk of blockage: High
Maintenance: Keep watercourse free of debris.
Quick Win: Remove timber 'screen'

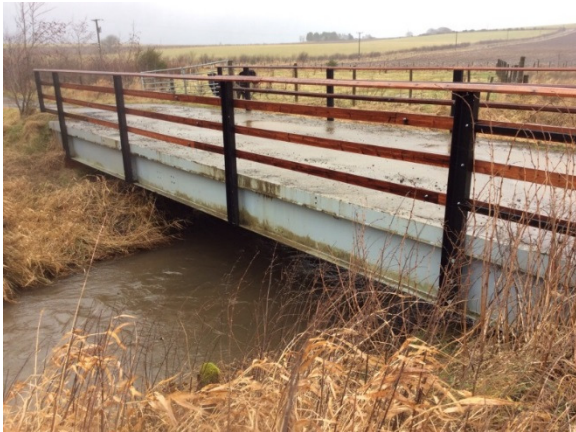
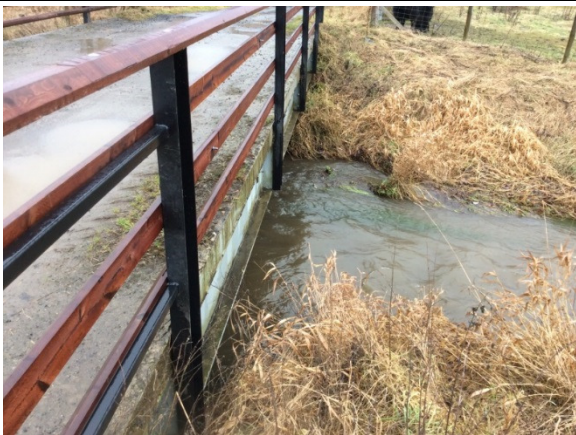
15 – Vehicular Bridge (Refer to Figure 2-5)

Type: Single Span Bridge
Upstream grid ref: NJ 64852 28702
Span (m): 4.5m approx.
Material: Steel Beam / Concrete Deck / Steel and Timber Parapet
Condition: Grade 2 (Good)
Part of FPS: No
Comments:
 Superficial corrosion of the beam upstream.
 Water stains on deck.
Risk of blockage: Moderate/High
Maintenance: Keep watercourse free of debris.
Quick Win: N/A

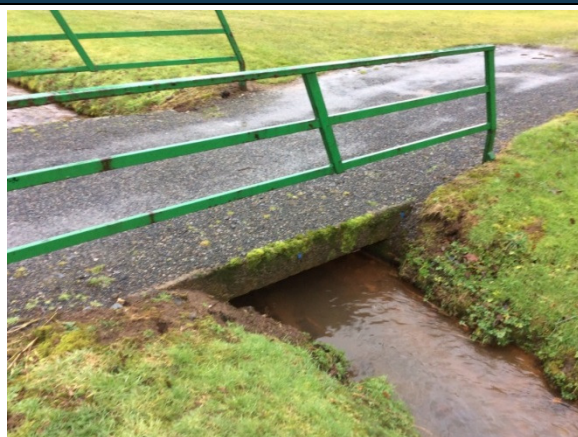
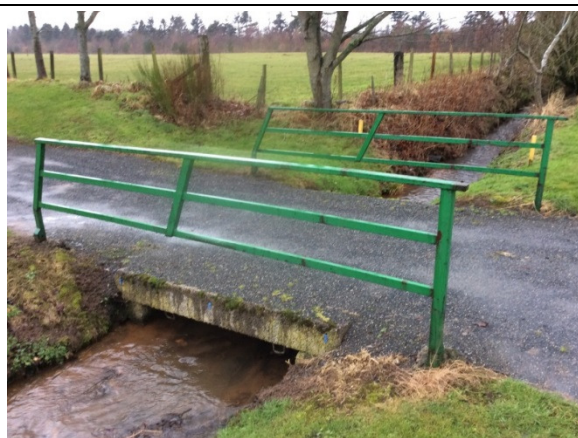
16 – Golf Course Pedestrian Bridge (Refer to Figure 3-1)

Type: Footbridge
Upstream grid ref: NJ 62487 28544
Span (m): 1 approx.
Material: Concrete
Condition: Grade 2 (Good)
Part of FPS: No
Comments:
 Distortion of handrails.
 Minor erosion of banks upstream.
Risk of blockage: High
Maintenance: Keep watercourse free of debris.
Quick Win: N/A

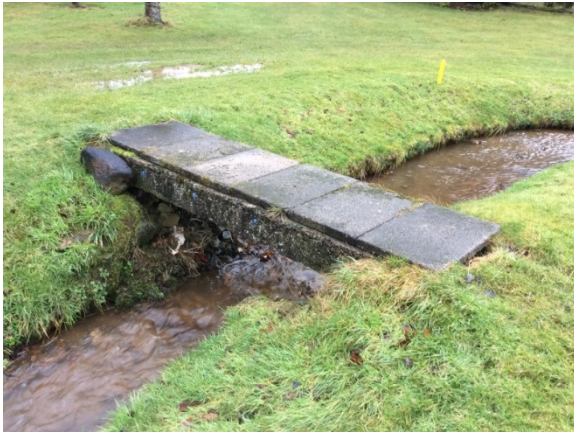
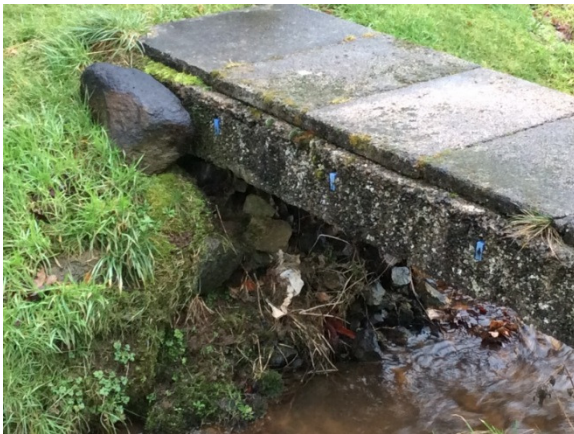
17 – Golf Course Pedestrian Bridge (Refer to Figure 3-1)

Type: Footbridge
Upstream grid ref: NJ 62503 28532
Span (m): 1 approx.
Material: Concrete
Condition: Grade 3 (Fair)
Part of FPS: No
Comments:
 No sound supports.
 Minor spalling of concrete.
 No Handrails.
 Narrow and potentially dangerous to use.
Risk of blockage: Moderate
Maintenance: Keep watercourse free of debris
Quick Win: N/A

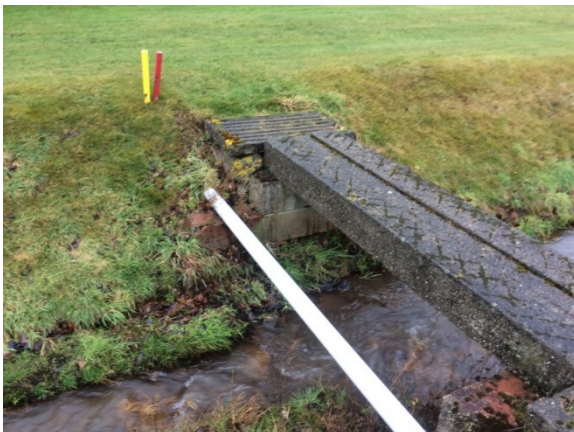
18 – Golf Course Pedestrian Bridge (Refer to Figure 3-1)

Type: Footbridge
Upstream grid ref: NJ 62554 28557
Span (m): 2 approx.
Material: Concrete Deck, Masonry Abutments
Condition: Grade 2 (Good)
Part of FPS: No
Comments:
 Vegetation growth through minor cracks.
 Bridge deck resting on masonry blocks.
 Pipe directly downstream of bridge.
 No Handrails.
 Narrow and potentially dangerous to use.
Risk of blockage: Moderate

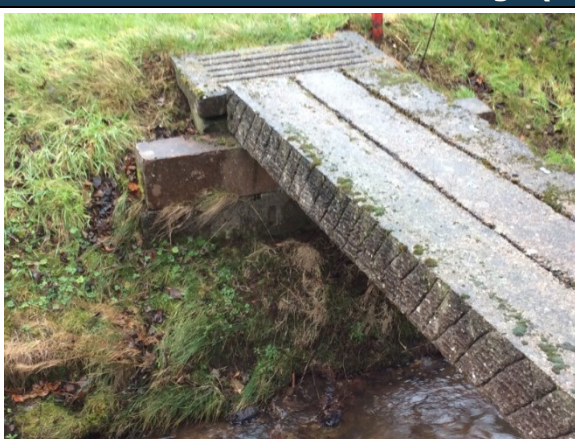
19 – Golf Course Pedestrian Bridge (Refer to Figure 3-1)

<p><i>Downstream view of bridge</i></p>	<p>Type: Footbridge Upstream grid ref: NJ 62605 28575 Span (m): 1 approx. Material: Concrete Deck, Masonry Abutments Condition: Grade 3 (Fair) Part of FPS: No Comments: Bridge deck resting on masonry abutments. No Handrails. Narrow and dangerous to use. Risk of blockage: Moderate Maintenance: Keep watercourse free of debris Quick Win: N/A</p>
---	--

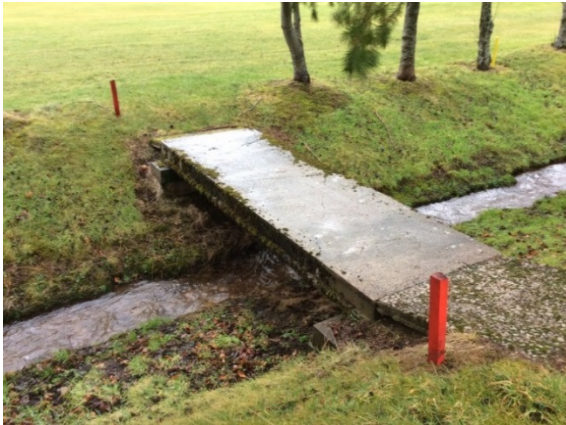
20 – Golf Course Pedestrian Bridge (Refer to Figure 3-1)

Type: Footbridge
Upstream grid ref: NJ 62689
28598
Span (m): 1 approx.
Width (m): 1 approx.
Material: Concrete Deck, Masonry
 Abutments
Condition: Grade 3 (Fair)
Part of FPS: No
Comments:
 Bridge deck resting on masonry
 blocks.
 Wearing of deck.
 No Handrails.
 Narrow and dangerous to use.
Risk of blockage: Moderate
Maintenance: Keep watercourse
 free of debris
Quick Win: N/A

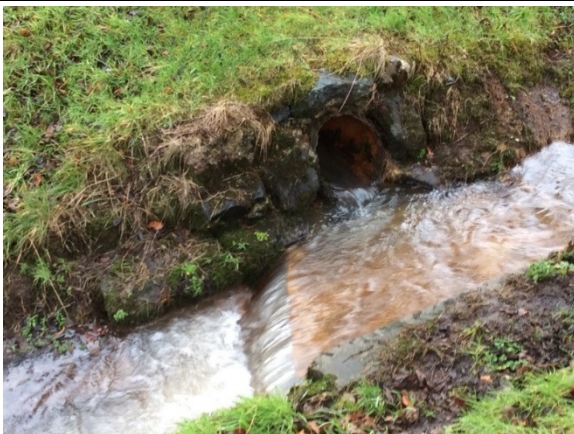
21 – Weir (Refer to Figure 3-1)

Type: Weir
Upstream grid ref: NJ 62693
28598
Width (m): 1 approx.
Material: Masonry
Condition: Grade 2 (Good)
Part of FPS: No
Comments:
 Even flow over crest
 Outfall directly upstream.
Risk of blockage: Moderate
Maintenance: Keep watercourse
 free of debris.
Quick Win: N/A

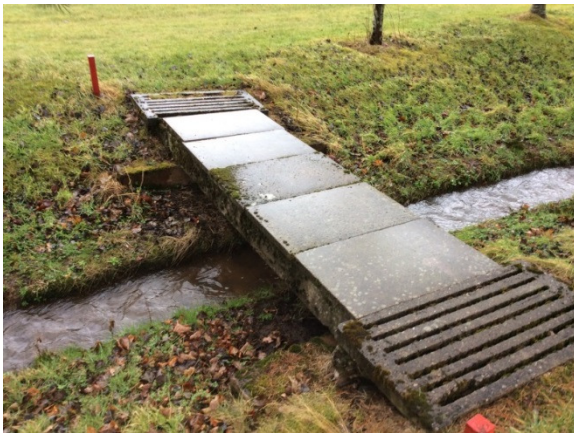
23 – Golf Course Pedestrian Bridge (Refer to Figure 3-1)

Type: Footbridge
Upstream grid ref: NJ 62737
28606
Span (m): 1 approx.
Width (m): 1 approx.
Material: Concrete Deck, Masonry Abutments
Condition: Grade 3 (Fair)
Part of FPS: No
Comments:
 No sound supports.
 Water stains.
 No Handrails.
 Narrow and potentially dangerous to use.
Risk of blockage: Moderate
Maintenance: Keep watercourse free of debris.
Quick Win: N/A

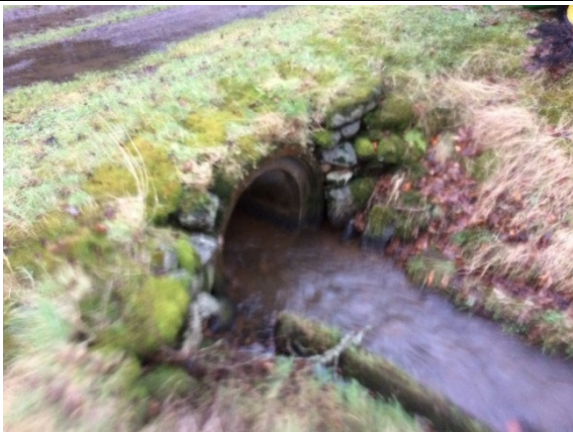
25 – Golf Course Culvert (Refer to Figure 3-1)

Type: Simple Culvert
Upstream grid ref: NJ 62900
28622
Material: Steel Pipe, Masonry Walls
Length (m): 4 approximately
Condition: Grade 2 (Good)
Part of FPS: No
Comments:
 No visible distortion to culvert shape.
 Minor displacement of stonework.
Risk of blockage: High
Maintenance: Keep watercourse free of debris.
Quick Win: N/A

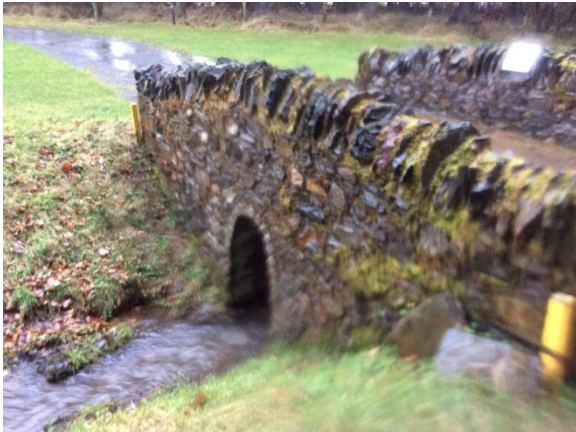
26 – Insch Golf Club Centenary Bridge (Refer to Figure 3-1)

Type: Masonry Bridge
Upstream grid ref: NJ 62938
28606
Span (m): 2 approx.
Material: Masonry
Condition: Grade 1 (Very good)
Part of FPS: No
Comments:
 No deformation of arch.
 No sign of cracking or movement.
 Minor vegetation growth between stonework.
Risk of blockage: Moderate
Maintenance: Keep watercourse free of debris.
Quick Win: N/A

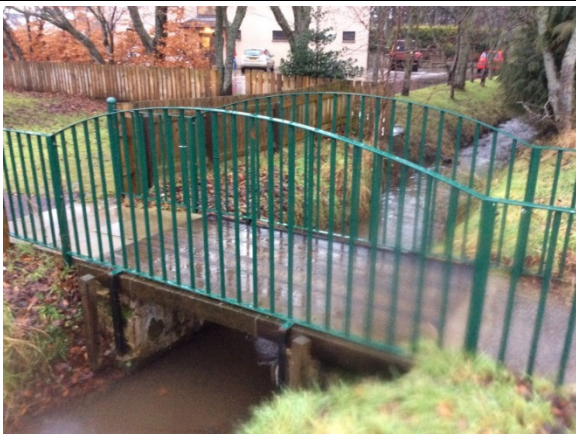
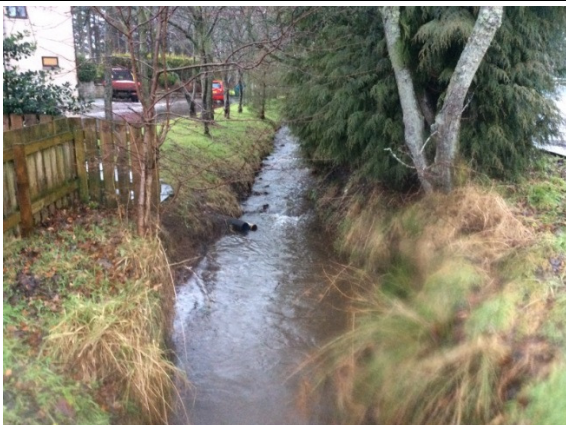
27 – Pedestrian Bridge (Refer to Figure 3-1)

Type: Footbridge
Upstream grid ref: NJ 63047
28563
Span (m): 2 approx.
Width (m): 1.45
Material: Timber Deck, Masonry Abutments
Condition: Grade 2 (Good)
Part of FPS: No
Comments:
 No sign of deformation.
 Minor rust of masonry abutments.
 Minor erosion of left bank downstream.
Risk of blockage: Moderate
Maintenance: Keep watercourse free of debris
Quick Win: N/A

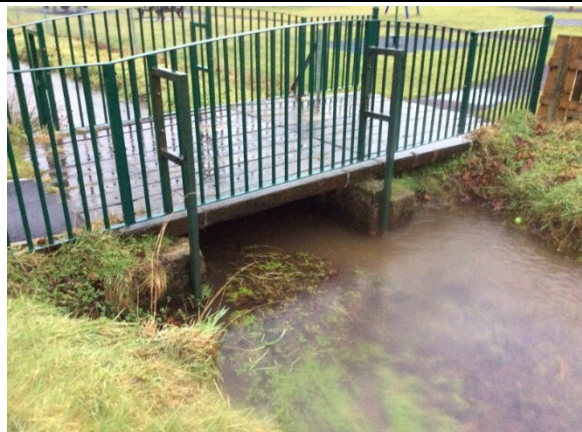
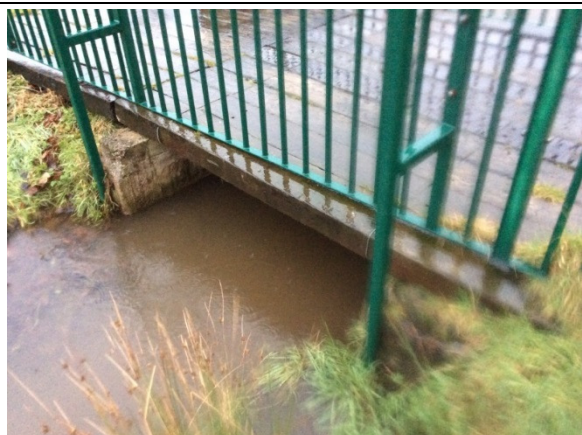
28 – Golf Course Pedestrian Bridge (Refer to Figure 3-1)

Type: Footbridge
Upstream grid ref: NJ 63079
28510
Span (m): Unknown
Width (m): 2.55
Material: Timber Deck, Masonry
 Abutments
Condition: Grade 2 (Good)
Part of FPS: No
Comments:
 Minor displacement of timber
 beams.
 Signs of minor timber rot.
Risk of blockage: Moderate/High
Maintenance: Keep watercourse
 free of debris.
Quick Win: N/A

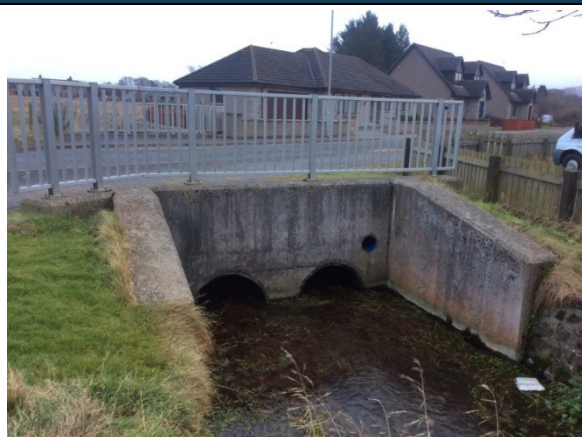
29 – Bennachie Bridge (Refer to Figure 3-1)

Type: Concrete Bridge with twin
 culverts
Upstream grid ref: NJ 63143
28481
Span (m): 1.28
Material: Concrete
Condition: Grade 2 (Good)
Part of FPS: No
Comments:
 Minor spalling of concrete.
 Surface damage only.
 Minor vegetation growth through
 minor cracks.
 Minor erosion upstream.
Risk of blockage: High
Maintenance: Keep watercourse
 free of debris.

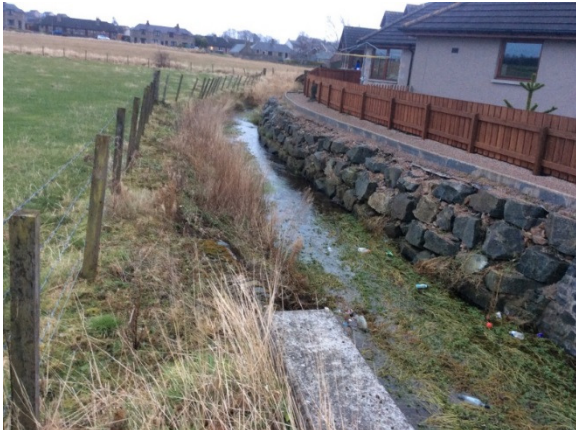
30 – Masonry Wall downstream of Bennachie Bridge (Refer to Figure 3-1)

Type: Flood Wall
Upstream grid ref: NJ 63156 28477
Material: Masonry
Condition: Grade 2 (Good)
Part of FPS: No
Comments:
 Blocks displaced or missing.
 Weed in watercourse.
 Unlikely to have been built to recognised standard.
Risk of blockage: Moderate
Maintenance: Keep watercourse free of debris.
Quick Win: N/A

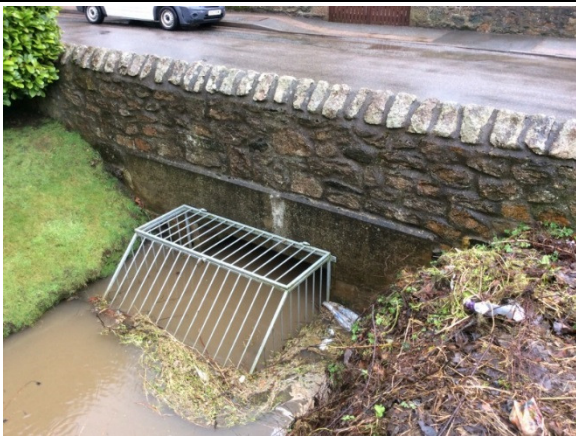
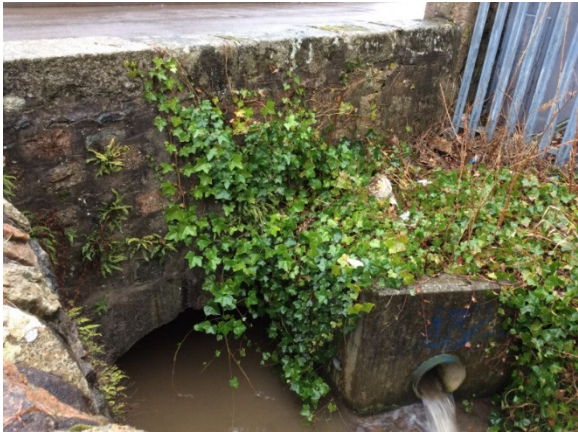
31 – Drumrossie Street Bridge B992 (Refer to Figure 3-1)

Type: Masonry Bridge
Upstream grid ref: NJ 63305 28301
Span (m): 1.5
Material: Masonry
Condition: Grade 2 (Good)
Part of FPS: No
Comments:
 Minor cracks.
 Minor masonry material missing from arch downstream.
 Poor access to trash screen upstream.
 Trash screen likely to be undersized.
 Outfall directly downstream.
 Well vegetated banks.
Risk of blockage: High
Maintenance: Keep watercourse free of debris.
Quick Win: New appropriately designed trash screen, increase capacity.

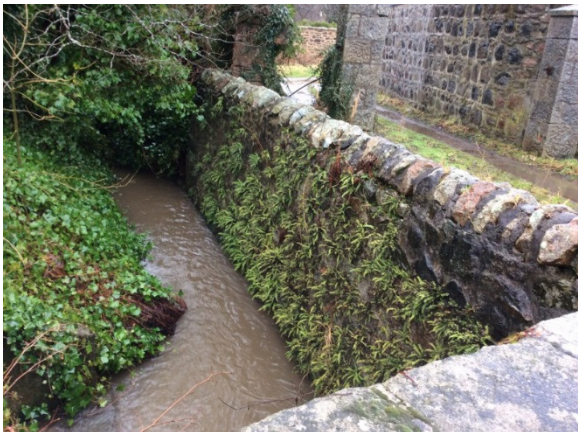
32 – Masonry Wall B992 (Refer to Figure 3-1)

Type: Flood Wall
Upstream grid ref: NJ 63306
28297
Height (m): 2 approx.
Material: Masonry
Condition: Grade 2 (Good)
Part of FPS: No
Comments:
 Wall downstream of Drumrossie Street Bridge.
 Vegetation growth between stonework.
 Minor lateral movement.
 Unlikely to prevent passage of water.
Risk of blockage: Low
Maintenance: None required
Quick Win: N/A

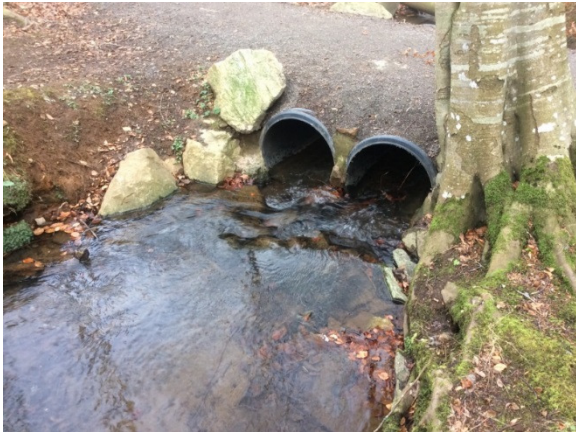
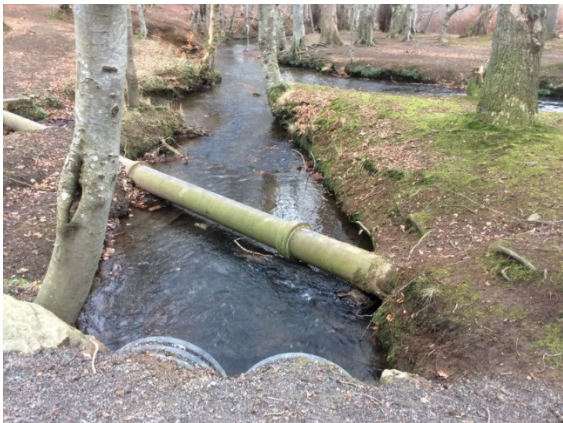
33– Inch Meadows Culvert (Refer to Figure 3-2)

Type: Twin bore Culvert
Upstream grid ref: NJ 63540
28070
Diameter: 0.2
Length (m): 1 approximately
Material: Corrugated HDPE
Condition: Grade 2 (Good)
Part of FPS: No
Comments:
 Pipe downstream of culvert.
Risk of blockage: High
Maintenance: Keep watercourse
 free of debris.
Quick Win: N/A

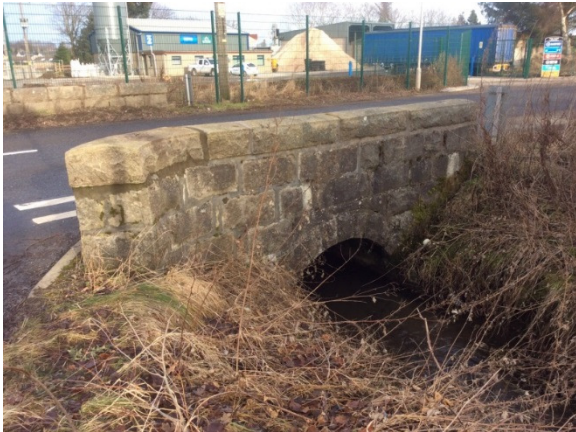
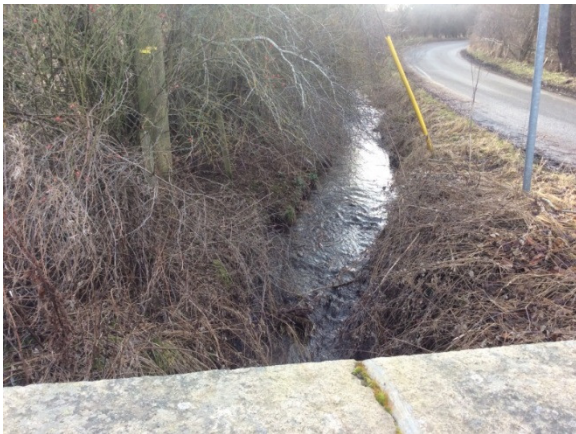
35 - Culvert B9002

Type: Masonry Culvert
Upstream grid ref: NJ 62586 27607
Diameter (m): 1 approx.
Material: Masonry
Condition: Grade 2 (Good)
Part of FPS: No
Comments:
 Minor cracks of arch.
 Minor vegetation growth between blocks.
 High vegetation growth of left bank downstream.
Risk of blockage: Moderate
Maintenance: Keep watercourse free of debris.
Quick Win: Remove excess vegetation downstream.

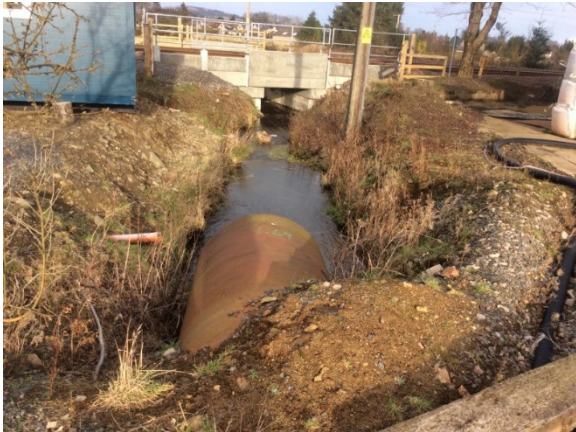
36 - Pipe downstream of the Rothney Railway Bridge (Refer to Figure 5-1)

Type: Pipe
Upstream grid ref: NJ 62616
27658
Material: Steel
Condition: Grade 2 (Good)
Part of FPS: No
Comments:
 Localised surface corrosion.
Risk of blockage: Moderate
Maintenance: Keep watercourse
 free of debris.
Quick Win: N/A

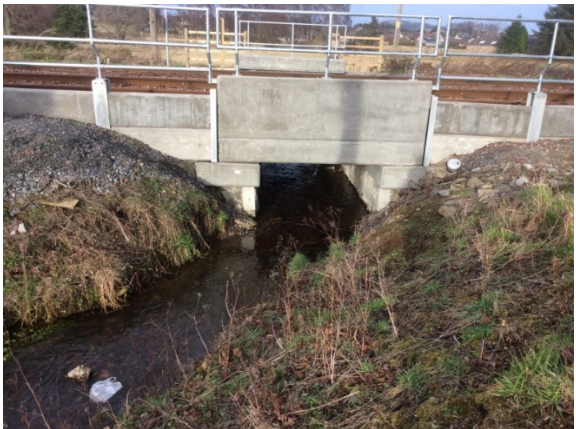
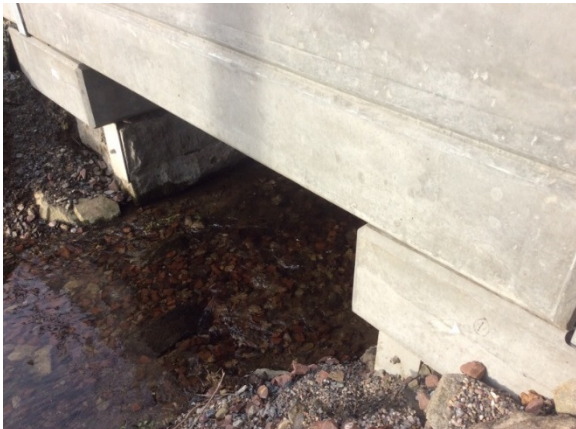
37 - Railway Bridge (Refer to Figure 5-1)

Type: Single Span Bridge
Upstream grid ref: NJ 62625
27682
Span (m): Unknown
Material: Concrete / Masonry
Condition: Grade 2 (Good)
Part of FPS: No
Comments:
 Abutments show minor cracks.
Risk of blockage: Moderate
Maintenance: Keep watercourse
 free of debris.
Quick Win: N/A

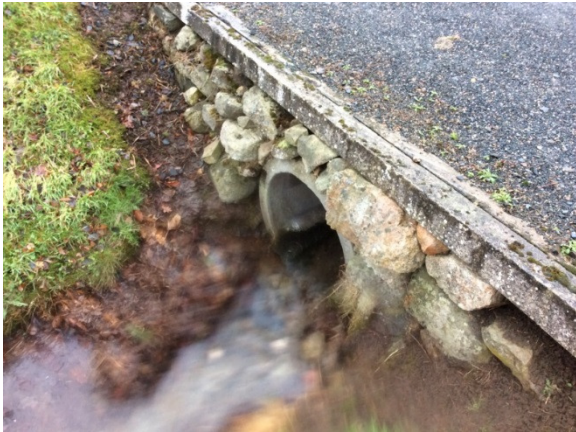
38 - Culvert (Refer to Figure 6-1)

Type: Circular Culvert
Upstream grid ref: NJ 62812 28661
Diameter (m): 0.3 approx.
Material: Masonry / Concrete
Condition: Grade 3 (Fair)
Part of FPS: No
Comments: Stonework missing.
Risk of blockage: High
Maintenance: Keep watercourse free of debris.
Quick Win: N/A

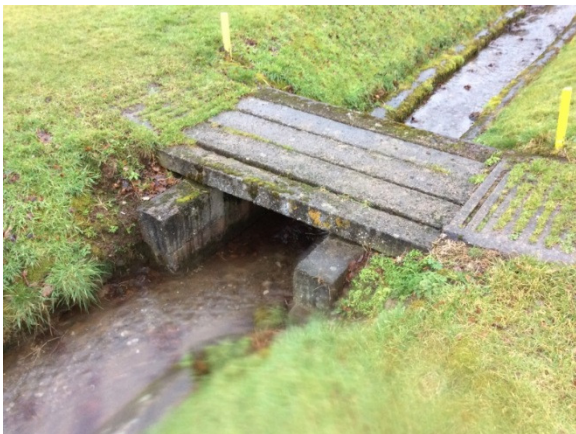
39 – Golf Course Pedestrian Bridge (Refer to Figure 6-1)

Type: Footbridge
Upstream grid ref: NJ 62828 28639
Span (m): 1 approx.
Material: Concrete
Condition: Grade 3 (Fair)
Part of FPS: No
Comments: Minor spalling. No Handrail.
Risk of blockage: High
Maintenance: Keep watercourse free of debris.
Quick Win: N/A

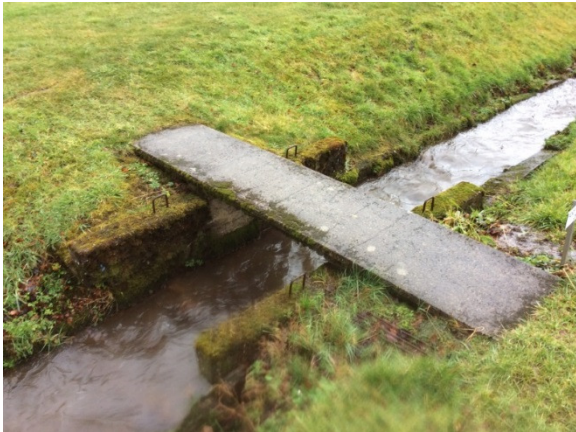
40 – Golf Course Pedestrian Bridge (Refer to Figure 6-1)

Type: Footbridge
Upstream grid ref: NJ 62835
28621
Span (m): 1 approx.
Material: Masonry
Condition: Grade 3 (Fair)
Part of FPS: No
Comments:
 Moss growth on abutments and deck.
 Minor spalling of deck.
 No Handrail.
 Narrow dangerous to use.
Risk of blockage: High
Maintenance: Keep watercourse free of debris
Quick Win: N/A

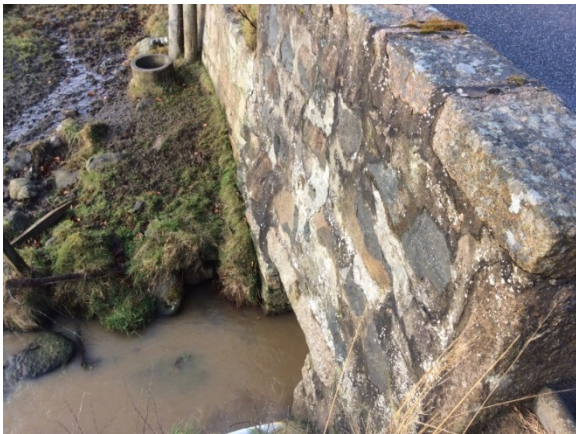
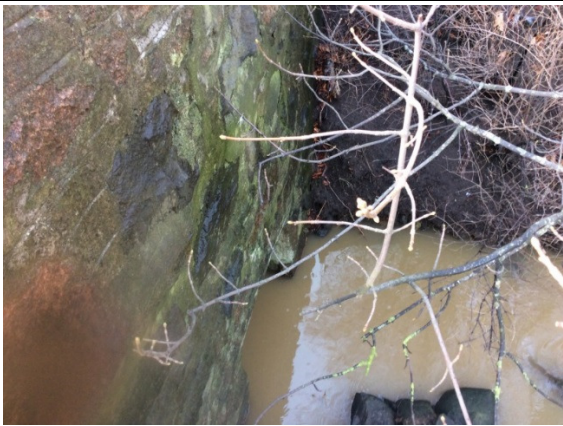
41 – South Road Culvert B9002 (Refer to Figure 7-1)

Type: Simple Culvert
Upstream grid ref: NJ 63910 27283
Material: Masonry
Condition: Grade 3 (Fair)
Part of FPS: No
Comments:
 Minor cracks.
 Water stains upstream.
 High and stiff vegetation growth upstream.
 Debris downstream.
Risk of blockage: High
Maintenance: Keep watercourse free of debris.
Quick Win: Remove excess vegetation and debris, investigate capacity.
