Insch Asset Condition Assessment

Final Report

01 May 2018

A structural survey was undertaken along the main watercourses of Inch in Aberdeenshire; the Shevock Burn, the Valentines Burn, the Temple Stripe, the Mill of Rothney, the Newton of Rothney and Field Drains of the Shevock Burn and the Valentines Burn.

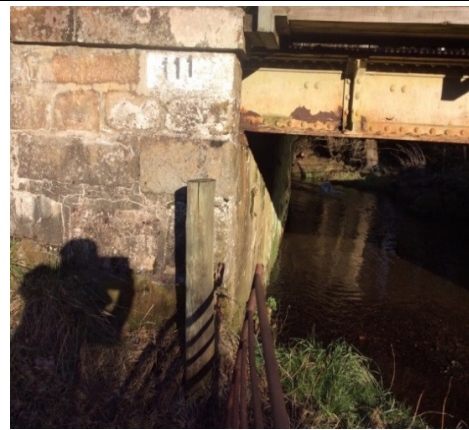
Upstream view – Left abutment

Type: Single Span Railway Bridge
Upstream grid ref: NJ 60666
27895
Span (m): 3 approx.
Material: Masonry Abutments, Steel Deck
Condition: Grade 2 (Good)
Part of FPS: No
Comments:
 Localised corrosion of steel beam.
 Minor cracks of abutments.
 Water stains at both abutments.
Risk of blockage: Low
Maintenance: None required
Quick Win: N/A

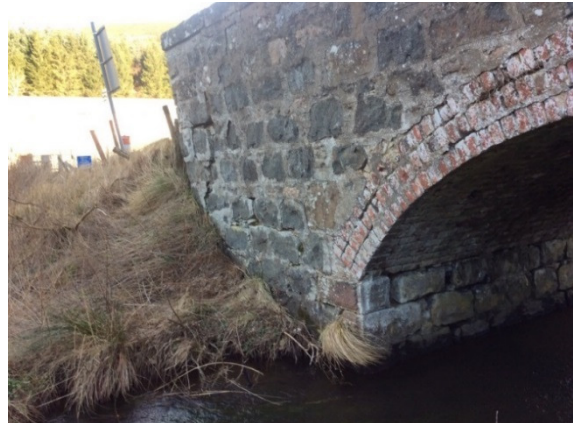
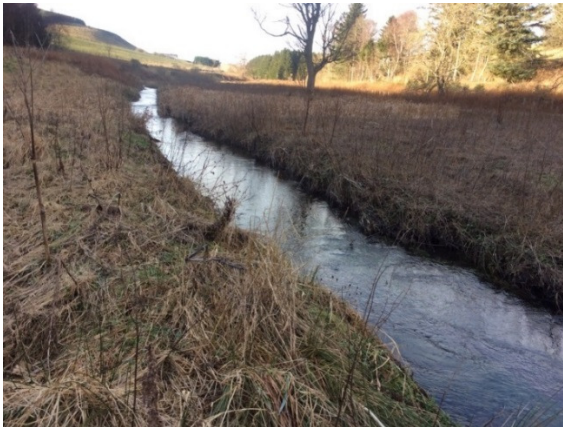
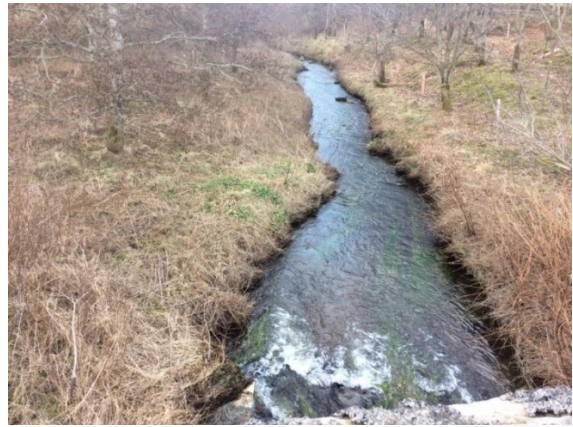
2- Masonry bridge (Refer to Figure 2-1)

Type: Arch Bridge
Upstream grid ref: NJ 60974
27754
Span (m): 2 approx.
Material: Masonry, Brick
Condition: Grade 3 (Fair)
Part of FPS: No
Comments:
 Loss of joint material.
 Masonry material missing.
 Extensive crack on left abutment.
 Arch deformed in places.
 Minor erosion of left bank downstream.
Risk of blockage: Moderate
Maintenance: Keep watercourse free of debris.
Quick Win: N/A

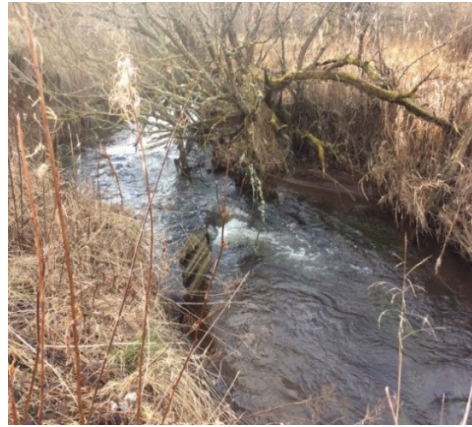
3 – ANI1 293/109 Railway Bridge (Refer to Figure 2-2)

Type: Bridge
Upstream grid ref: NJ 61995 27655
Span (m): 1 approx. each opening
Material: Concrete Abutments and Deck
Condition: Grade 2 (Good)
Part of FPS: No
Comments:
 Water stains.
 No significant defects of structure.
 Corrosion of parapet.
 High vegetation growth upstream.
Risk of blockage: Moderate
Maintenance: Keep watercourse free of debris.
Quick Win: Remove excess vegetation, cut trees upstream.

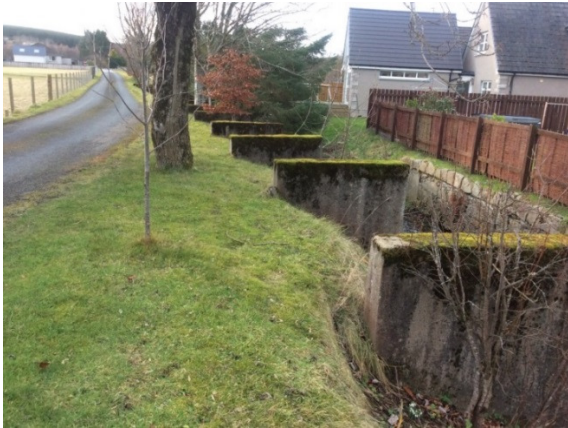
4 – Redundant Structures (Refer to Figure 2-3)

Type: Redundant Structures
Upstream grid ref: NJ 62924 27856
Material: Concrete
Part of FPS: No
Comments: Possibly connected with the Mill of Rothney (located near exit mill lade now infilled). Could possibly increase flood spilling to opposite bank.
Risk of blockage: N/A
Maintenance: N/A
Quick Win: Consider removing these structures

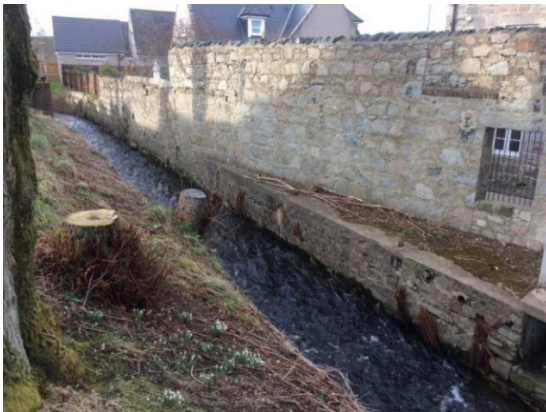
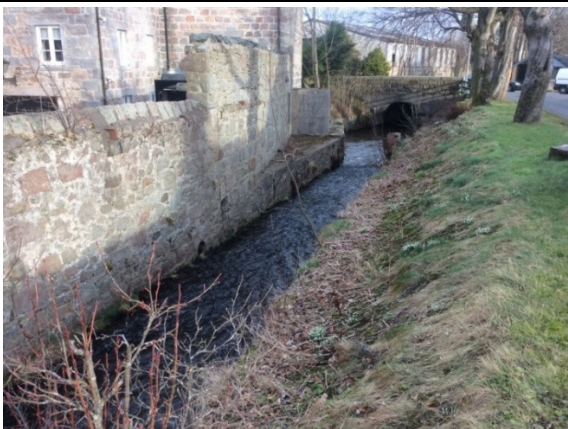
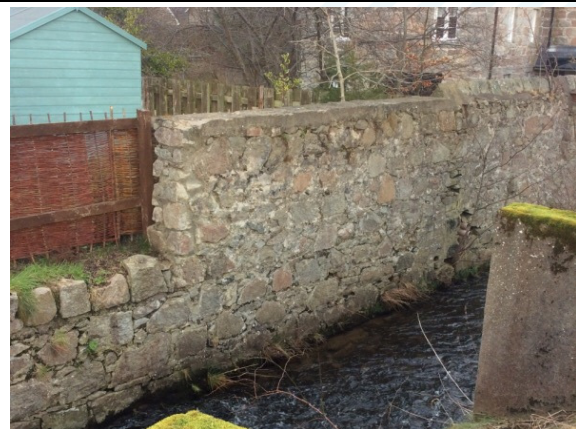
5 – Retaining wall upstream of Bridge of Rothney (Refer to Figure 2-3)

Type: Flood Wall
Upstream grid ref: NJ 62959 27859
Height (m): Different heights, unknown
Material: Masonry
Condition: Grade 3 (Fair)
Part of FPS: No
Comments: Minor cracks. Loss of joint material. Minor displacement of blocks.
Risk of blockage: Low
Maintenance: None required
Quick Win: N/A

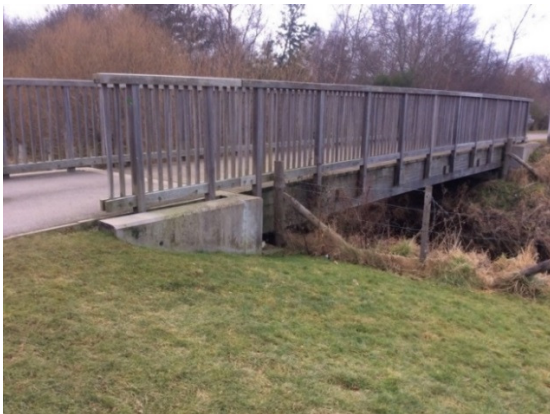
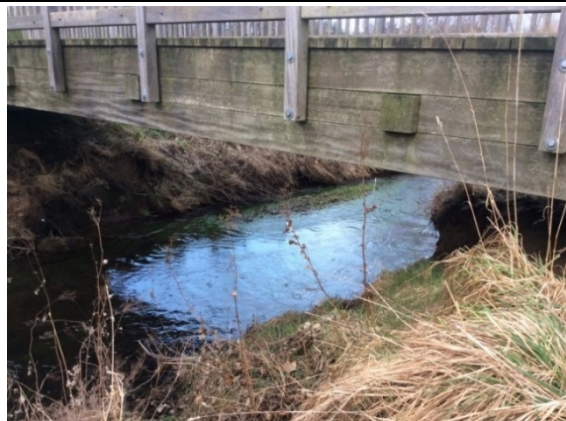
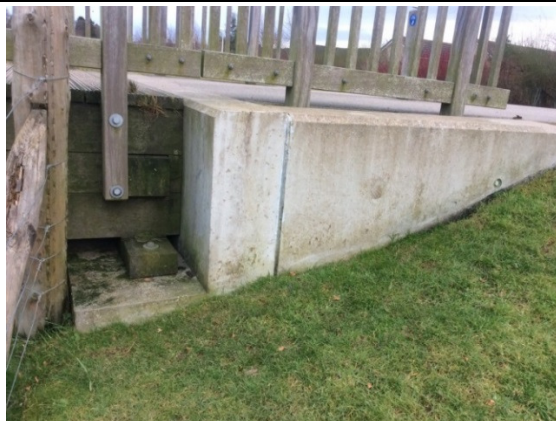
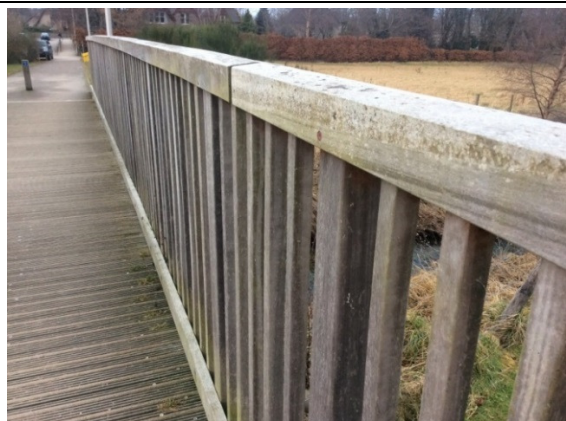
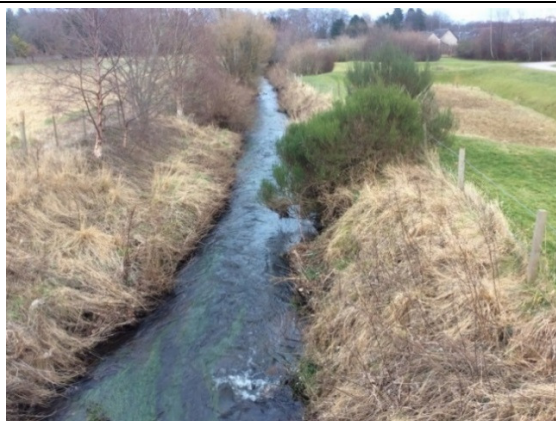
7 – Old Mart Footbridge (Refer to Figure 2-3)

Type: Single Span Pedestrian Bridge
Upstream grid ref: NJ 63169 27841
Span (m): 4 approx.
Width (m): 3
Material: Timber Structure and Deck, Concrete Abutments
Condition: Grade 2 (Good)
Part of FPS: No
Comments:
 Sound abutments.
 Fixings present.
 Signs of superficial rot of timber
Risk of blockage: Low
Maintenance: None required
Quick Win: N/A

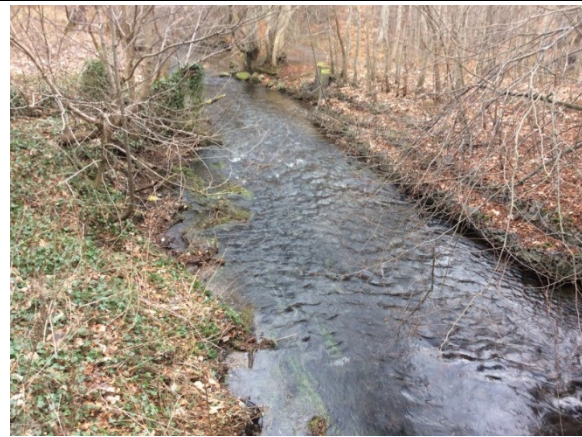
Type: Masonry Arch Bridge
Upstream grid ref: NJ 63428 27991
Span (m): 5.13
Material: Masonry
Condition: Grade 2 (Good)
Part of FPS: No
Comments:
 No deformation of arch.
 Minor spalling.
 Moss growth on top.
 Gabion baskets directly downstream.
 Service pipe downstream.
Risk of blockage: Moderate
Maintenance: Keep watercourse free of debris.
Quick Win: N/A

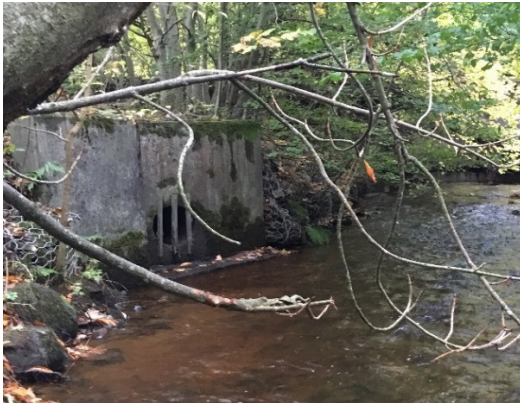
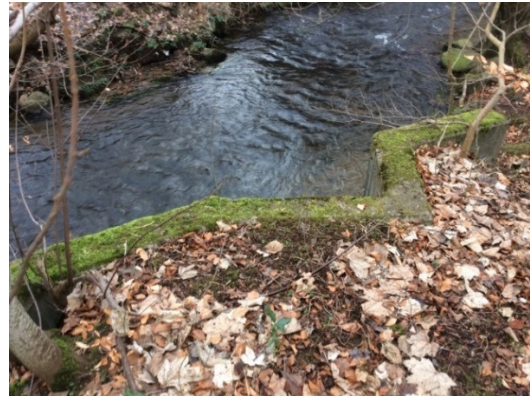
Type: Concrete Wall, Outfall with Trash Screen
Upstream grid ref: NJ 63453 27998
Height (m): 1.6
Thickness (m): 0.2
Length (m): 3 approx.
Material: Concrete
Condition: Grade 2 (Good)
Part of FPS: No
Comments:
 No significant defects.
 Moss growth on wall.
Risk of blockage: High
Maintenance: Keep watercourse and trash screen free of debris
Quick Win: N/A

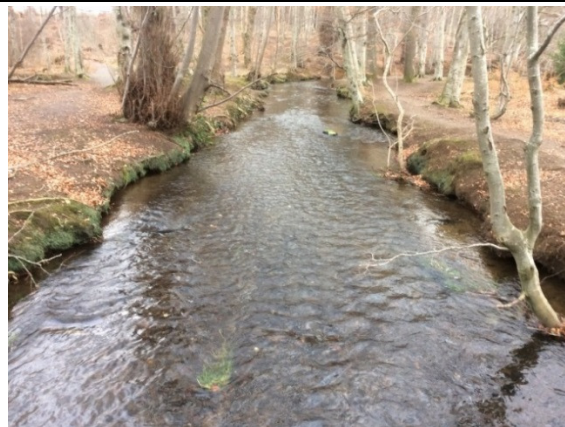
12 – Insch Meadows Pedestrian Bridge (Refer to Figure 2-3)

Type: Timber Footbridge
Upstream grid ref: NJ 63496 28030
Span (m): 6 approx.
Width (m): 1.05
Material: Timber
Condition: Grade 2 (Good)
Part of FPS: No
Comments:
 Handrails show signs of rot.
 Minor erosion of banks upstream and downstream.
 No deformation of timber beam.
Risk of blockage: Moderate
Maintenance: Keep watercourse free of debris.
Quick Win: N/A

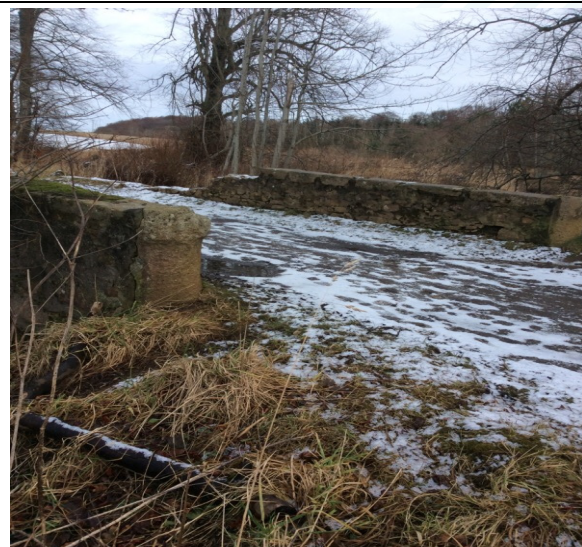
13 – Drumrossie House Bridge (Refer to Figure 2-4)

Type: Masonry Arch Bridge
Upstream grid ref: NJ 63972 27946
Span (m): 10.5
Material: Masonry
Condition: Grade 4 (Poor)
Part of FPS: No
Comments:
 Masonry missing (especially on parapet).
 Loss of mortar.
Risk of blockage: Moderate
Maintenance: Keep watercourse free of debris
Quick Win: N/A

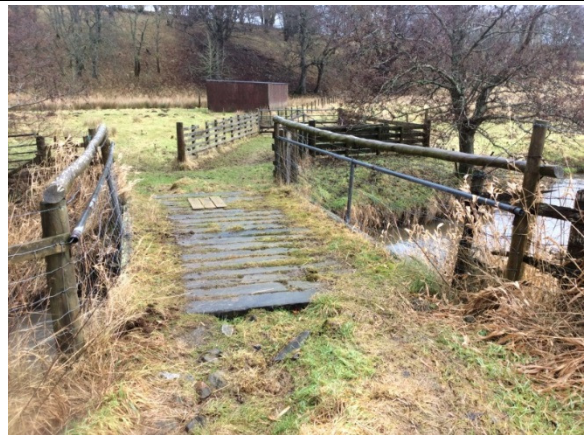
14 – Mains of Rothney Footbridge (Refer to Figure 2-4)

Type: Pedestrian Bridge
Upstream grid ref: NJ 64284 28405
Span (m): Unknown
Material: Timber/ Steel handrails and wire
Condition: Grade 4 (Poor)
Part of FPS: No
Comments:
 Rotten timber.
 Vegetation growth between timber planks.
 Distorted handrails.
Risk of blockage: High
Maintenance: Keep watercourse free of debris.
Quick Win: Remove timber 'screen'

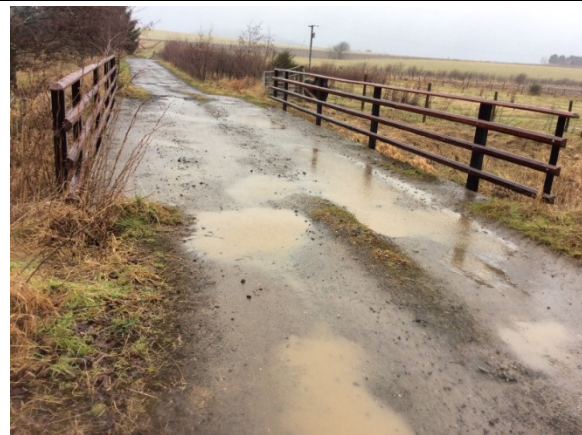
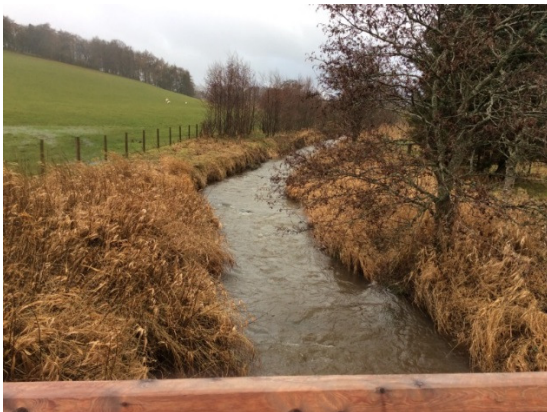
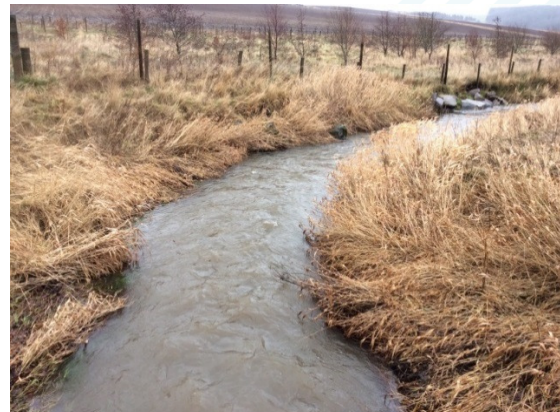
15 – Vehicular Bridge (Refer to Figure 2-5)

Type: Single Span Bridge
Upstream grid ref: NJ 64852 28702
Span (m): 4.5m approx.
Material: Steel Beam / Concrete Deck / Steel and Timber Parapet
Condition: Grade 2 (Good)
Part of FPS: No
Comments:
 Superficial corrosion of the beam upstream.
 Water stains on deck.
Risk of blockage: Moderate/High
Maintenance: Keep watercourse free of debris.
Quick Win: N/A

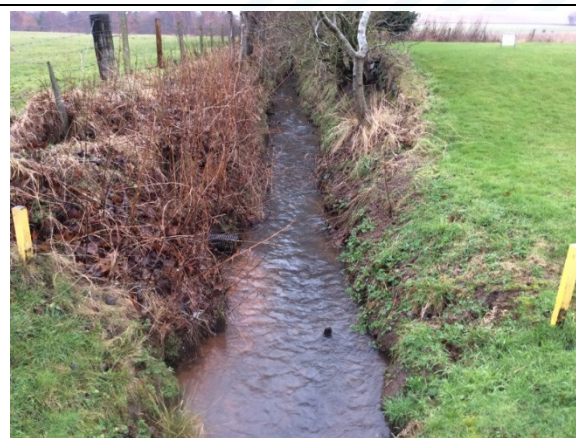
Type: Footbridge
Upstream grid ref: NJ 62487 28544
Span (m): 1 approx.
Material: Concrete
Condition: Grade 2 (Good)
Part of FPS: No
Comments:
 Distortion of handrails.
 Minor erosion of banks upstream.
Risk of blockage: High
Maintenance: Keep watercourse free of debris.
Quick Win: N/A

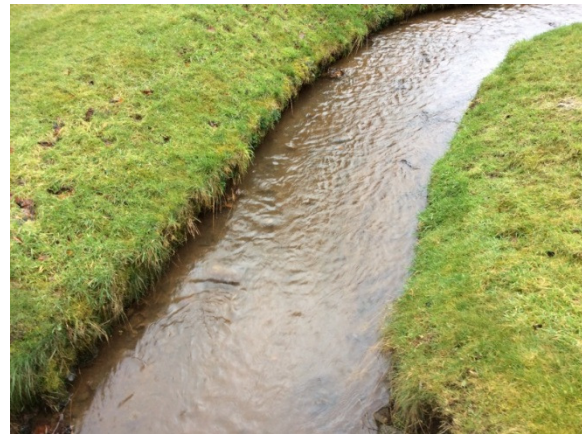
17 – Golf Course Pedestrian Bridge (Refer to Figure 3-1)

Type: Footbridge
Upstream grid ref: NJ 62503 28532
Span (m): 1 approx.
Material: Concrete
Condition: Grade 3 (Fair)
Part of FPS: No
Comments:
 No sound supports.
 Minor spalling of concrete.
 No Handrails.
 Narrow and potentially dangerous to use.
Risk of blockage: Moderate
Maintenance: Keep watercourse free of debris
Quick Win: N/A

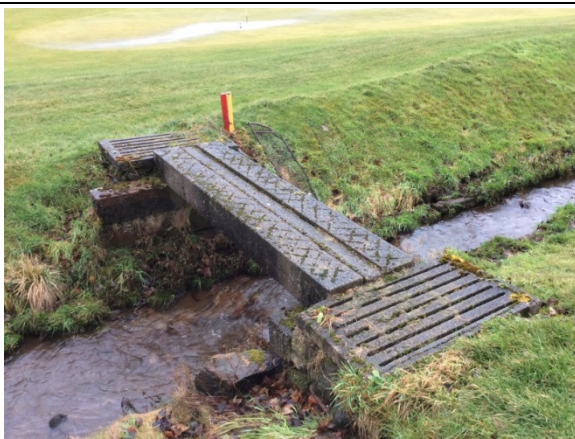
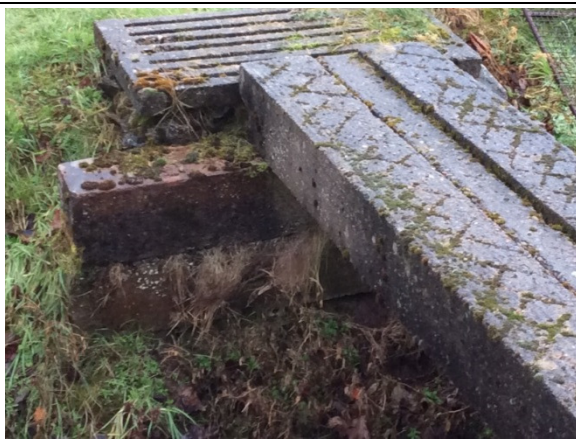
18 – Golf Course Pedestrian Bridge (Refer to Figure 3-1)

Type: Footbridge
Upstream grid ref: NJ 62554 28557
Span (m): 2 approx.
Material: Concrete Deck, Masonry Abutments
Condition: Grade 2 (Good)
Part of FPS: No
Comments:
 Vegetation growth through minor cracks.
 Bridge deck resting on masonry blocks.
 Pipe directly downstream of bridge.
 No Handrails.
 Narrow and potentially dangerous to use.
Risk of blockage: Moderate

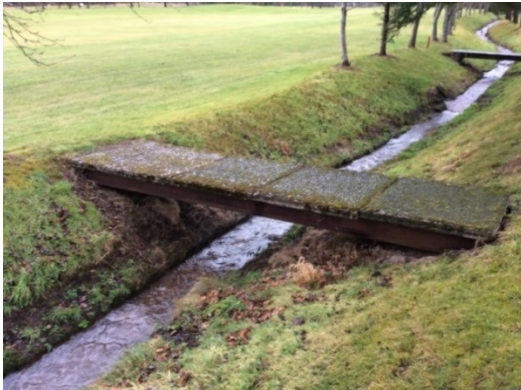
22 – Golf Course Pedestrian Bridge (Refer to Figure 3-1)

Type: Footbridge
Upstream grid ref: NJ 62708
28602
Span (m): 1 approx.
Material: Steel Beam, Stonework Deck
Condition: Grade 2 (Good)
Part of FPS: No
Comments:
 No Handrails.
 Narrow and potentially dangerous to use.
Risk of blockage: Moderate
Maintenance: Keep watercourse free of debris.
Quick Win: N/A

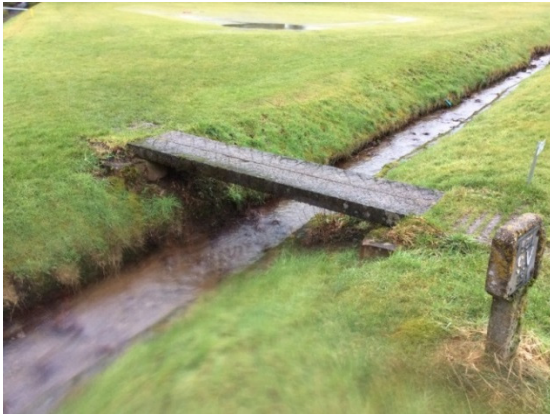
24 – Golf Course Pedestrian Bridge (Refer to Figure 3-1)

Type: Footbridge
Upstream grid ref: NJ 62845
28619
Span (m): 2 approx.
Width (m): 1 approx.
Material: Concrete Deck, Masonry Abutments
Condition: Grade 3 (Fair)
Part of FPS: No
Comments:
 No Handrails.
 Narrow and potentially dangerous to use.
Risk of blockage: Moderate
Maintenance: Keep watercourse free of debris.
Quick Win: N/A

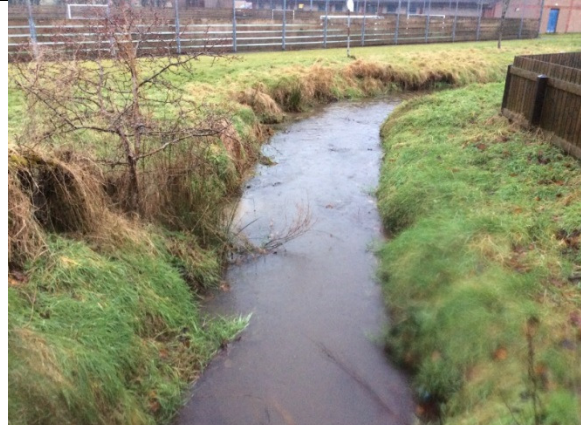
Type: Footbridge
Upstream grid ref: NJ 63047
28563
Span (m): 2 approx.
Width (m): 1.45
Material: Timber Deck, Masonry Abutments
Condition: Grade 2 (Good)
Part of FPS: No
Comments:
 No sign of deformation.
 Minor rust of masonry abutments.
 Minor erosion of left bank downstream.
Risk of blockage: Moderate
Maintenance: Keep watercourse free of debris
Quick Win: N/A

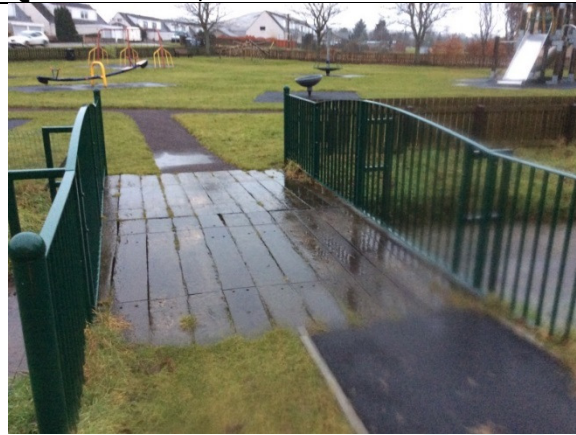
28 – Golf Course Pedestrian Bridge (Refer to Figure 3-1)

Type: Footbridge
Upstream grid ref: NJ 63079
28510
Span (m): Unknown
Width (m): 2.55
Material: Timber Deck, Masonry
 Abutments
Condition: Grade 2 (Good)
Part of FPS: No
Comments:
 Minor displacement of timber
 beams.
 Signs of minor timber rot.
Risk of blockage: Moderate/High
Maintenance: Keep watercourse
 free of debris.
Quick Win: N/A

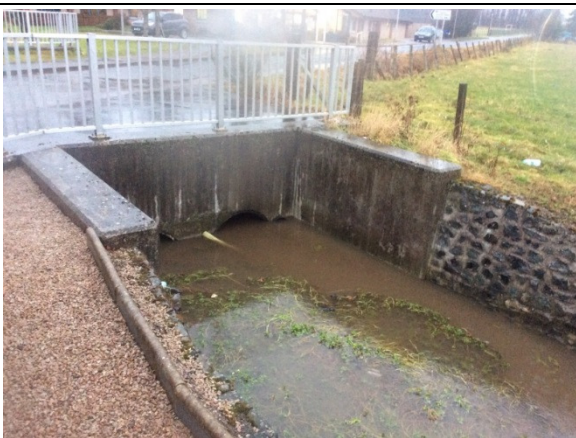
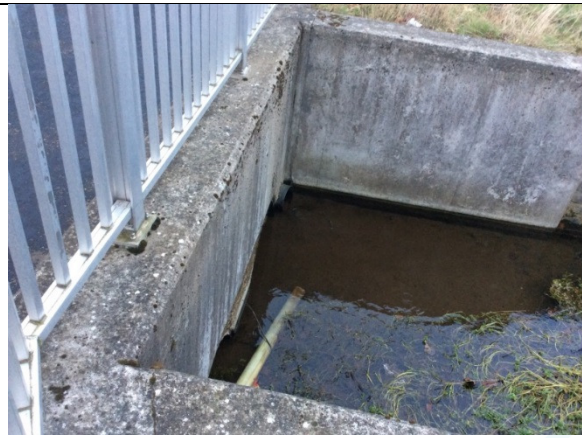
29 – Bennachie Bridge (Refer to Figure 3-1)

Type: Concrete Bridge with twin
 culverts
Upstream grid ref: NJ 63143
28481
Span (m): 1.28
Material: Concrete
Condition: Grade 2 (Good)
Part of FPS: No
Comments:
 Minor spalling of concrete.
 Surface damage only.
 Minor vegetation growth through
 minor cracks.
 Minor erosion upstream.
Risk of blockage: High
Maintenance: Keep watercourse
 free of debris.

Quick Win: Add appropriately designed trash screen. Investigate capacity and bed levels.

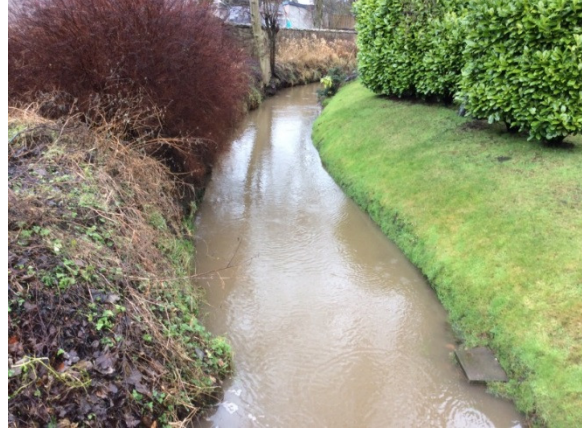
Upstream view of watercourse

Type: Masonry Bridge
Upstream grid ref: NJ 63305 28301
Span (m): 1.5
Material: Masonry
Condition: Grade 2 (Good)
Part of FPS: No
Comments:
 Minor cracks.
 Minor masonry material missing from arch downstream.
 Poor access to trash screen upstream.
 Trash screen likely to be undersized.
 Outfall directly downstream.
 Well vegetated banks.
Risk of blockage: High
Maintenance: Keep watercourse free of debris.
Quick Win: New appropriately designed trash screen, increase capacity.

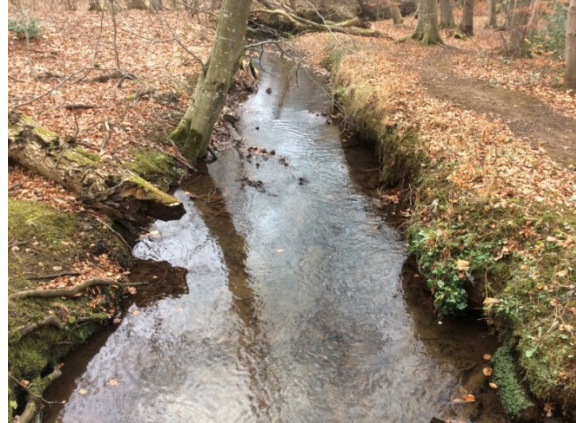
Upstream view of watercourse

Type: Twin bore Culvert
Upstream grid ref: NJ 63540
28070
Diameter: 0.2
Length (m): 1 approximately
Material: Corrugated HDPE
Condition: Grade 2 (Good)
Part of FPS: No
Comments:
 Pipe downstream of culvert.
Risk of blockage: High
Maintenance: Keep watercourse
 free of debris.
Quick Win: N/A

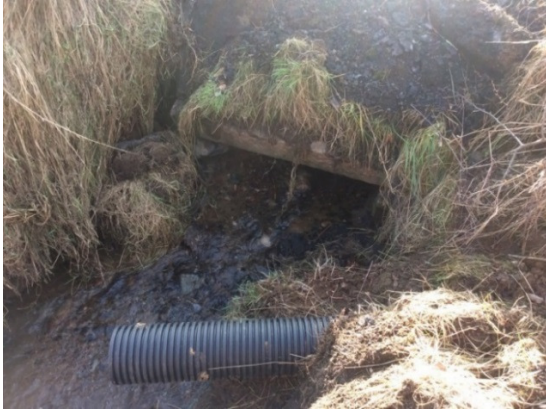
Upstream view

Type: Culvert and Outfall
Upstream grid ref: NJ 61430 27559
Span (m): 1 approx.
Material: Concrete
Condition: Grade 2 (Good)
Part of FPS: No
Comments:
 Outfall pipe directly upstream of culvert.
Risk of blockage: High
Maintenance: Keep watercourse free of debris.
Quick Win: N/A

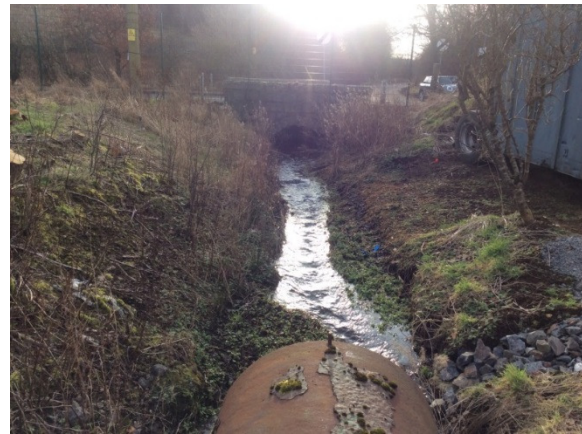
Upstream side of culvert

Type: Masonry Culvert
Upstream grid ref: NJ 62586 27607
Diameter (m): 1 approx.
Material: Masonry
Condition: Grade 2 (Good)
Part of FPS: No
Comments:
 Minor cracks of arch.
 Minor vegetation growth between blocks.
 High vegetation growth of left bank downstream.
Risk of blockage: Moderate
Maintenance: Keep watercourse free of debris.
Quick Win: Remove excess vegetation downstream.

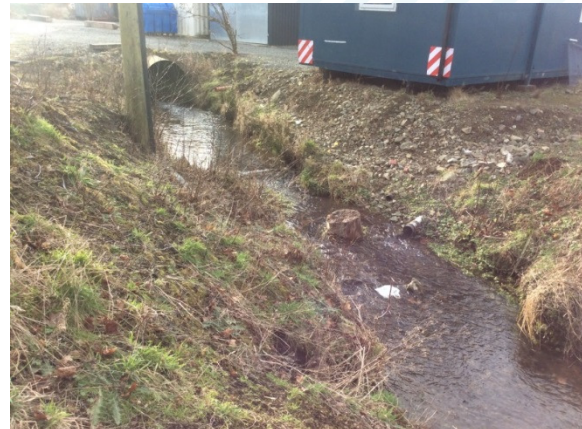
Downstream view of watercourse

Type: Single Span Bridge
Upstream grid ref: NJ 62625
27682
Span (m): Unknown
Material: Concrete / Masonry
Condition: Grade 2 (Good)
Part of FPS: No
Comments:
 Abutments show minor cracks.
Risk of blockage: Moderate
Maintenance: Keep watercourse
 free of debris.
Quick Win: N/A

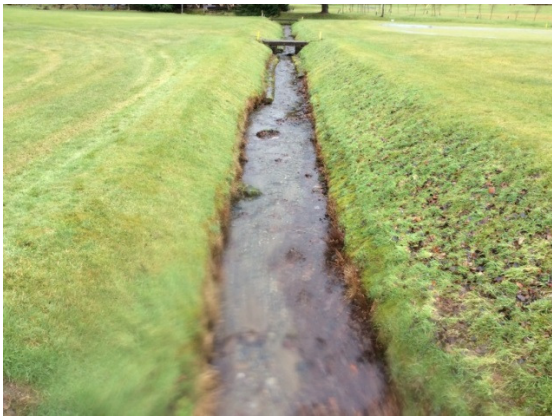
Upstream view of watercourse

Type: Circular Culvert
Upstream grid ref: NJ 62812 28661
Diameter (m): 0.3 approx.
Material: Masonry / Concrete
Condition: Grade 3 (Fair)
Part of FPS: No
Comments: Stonework missing.
Risk of blockage: High
Maintenance: Keep watercourse free of debris.
Quick Win: N/A

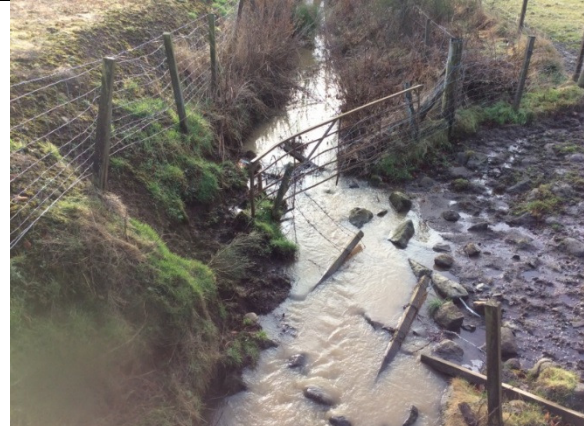
Downstream view of watercourse

Type: Simple Culvert
Upstream grid ref: NJ 63910 27283
Material: Masonry
Condition: Grade 3 (Fair)
Part of FPS: No
Comments:
 Minor cracks.
 Water stains upstream.
 High and stiff vegetation growth upstream.
 Debris downstream.
Risk of blockage: High
Maintenance: Keep watercourse free of debris.
Quick Win: Remove excess vegetation and debris, investigate capacity.

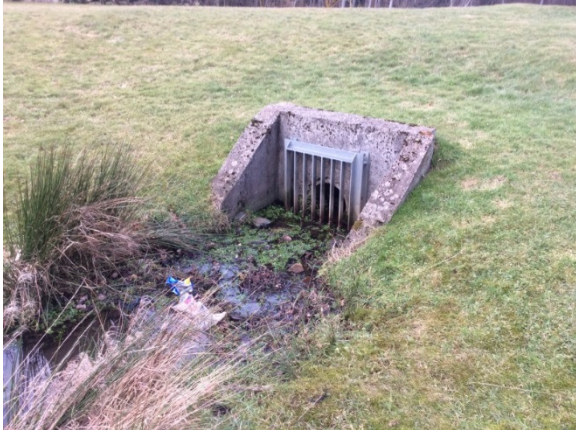
Inlet pipe and headwall with bar screen (Sinks)

Condition: Grade 2 (Good)

Spalling of concrete.

Maintenance: Keep watercourse free of trash and debris.

Quick Win: Consider removing sediment

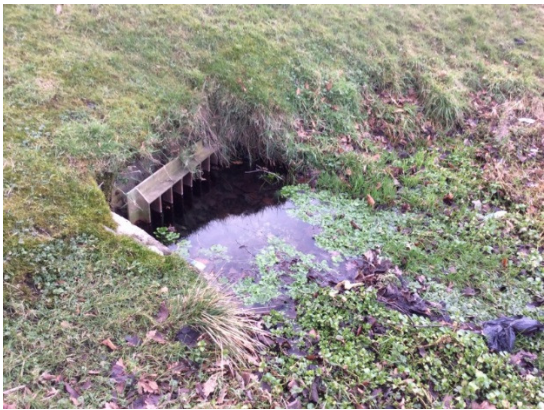
Culvert outlet with screen

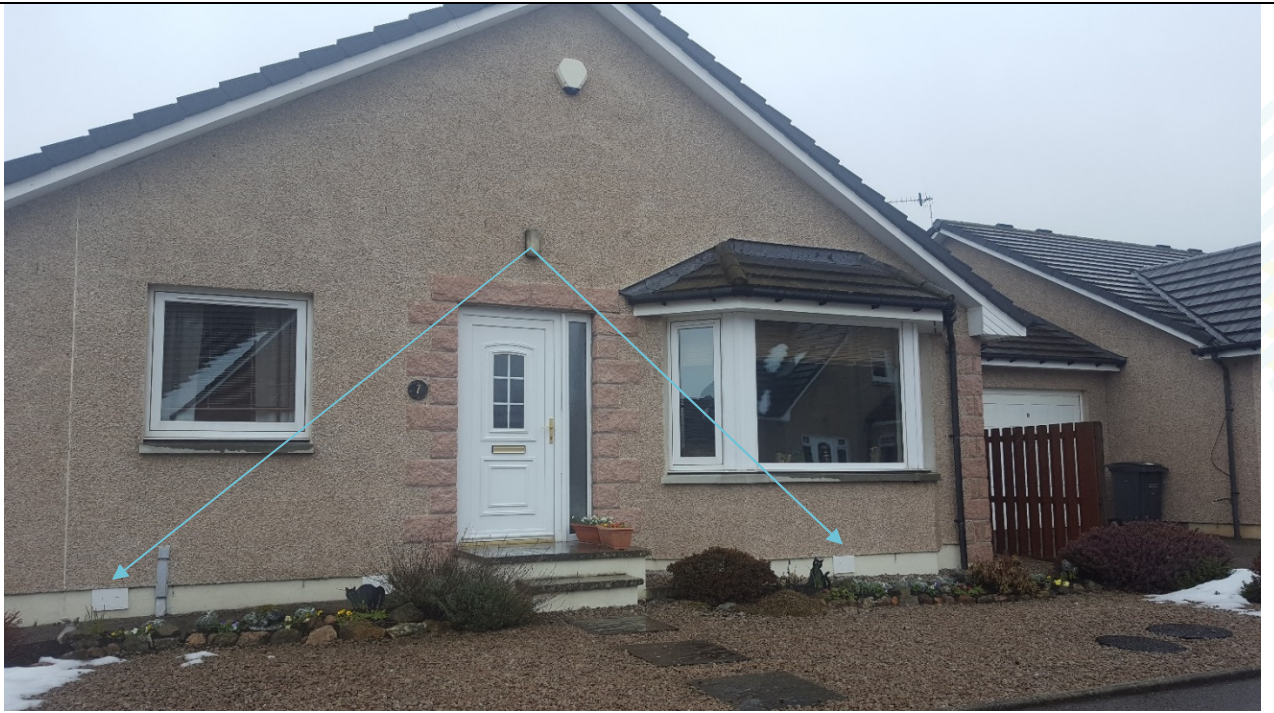
Figure 9-3: Property Level Protection of 7 Old Mart Avenue

All properties have used airbrick covers as a measure to mitigate flood risk. Figure 9-3, Figure 9-4 and Figure 9-5 show the PLP products used in the residential properties shown above.
